## Turbocharger

## Troubleshooting Guidelines

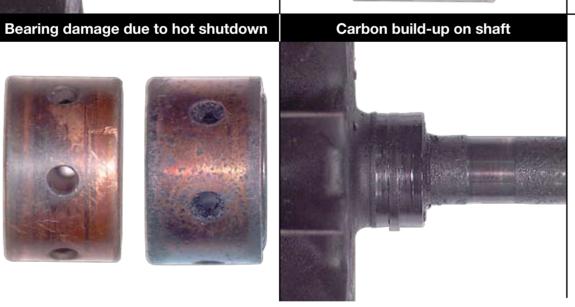
Failure from excessive exhaust temperatures or hot shutdown of engine results in carbon build-up. It is recommended that you idle the engine for two to three minutes to cool the bearing system before shutting down. Turbine end heat soak into the bearing housing results in oil carbonisation and corrosion of the bearing system. The main damage occurs to the shaft seal ring and grooves, turbine end bearing and bearing housing oil drain cavity blockage.

Carbon build-up can be caused by:

Hot shutdown of engine

- Degraded oil quality carbonising in service
- Infrequent oil change intervals causing oil breakdown in service
- Air and gas leaks
- Faulty fuel injector pump/injectors.
